AIRCRAFT GROUND-FLOTATION INVESTIGATION
PART XII — DATA REPORT ON TEST SECTION 12

W. BRABSTON and G. HAMMITT II
U. S. ARMY ENGINEER WATERWAYS EXPERIMENT STATION

TECHNICAL REPORT AFFDL-TR-66-43, PART XII

SEPTEMBER 1966

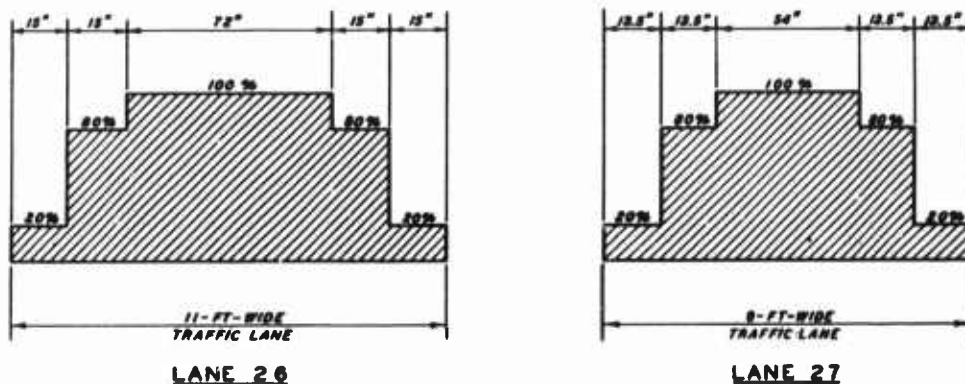
NOTE: PERCENTAGE FIGURES SHOW PERCENT
OF TOTAL COVERAGES.

Figure 1. Traffic distribution patterns, Test Section 12

Traffic was applied to the test lanes in a nonuniform pattern with intensity of traffic being varied within each lane to produce three zones of approximately 100, 80, and 20 percent traffic coverage. Traffic so distributed within a traffic lane simulates as nearly as possible the bell-shaped traffic distribution curve which results from the wander of aircraft from the lane center line. The coverage levels referred to in the tables and text of this part are the total number of coverages applied to the 100 percent coverage zone. The corresponding number of coverages applied to the outer traffic zones is proportional to the percentage factor for the respective zones, as shown in figure 1. In lane 26 the lane width was not an exact multiple of the tracking-tire widths and spacings so that it was necessary to determine a coverage factor to compensate for small gaps in the traffic pattern.

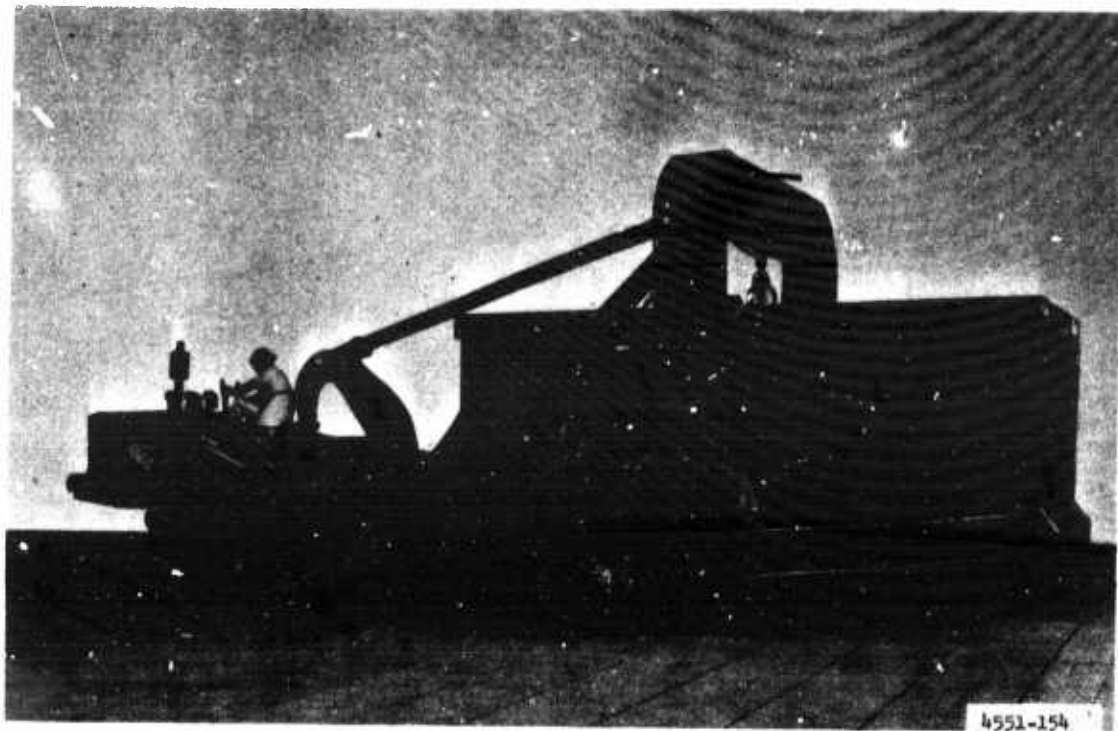
Figure 2. Test load vehicle

The load vehicle used in trafficking lanes in Section 12 is shown in figure 2. Load cart construction, details of linkage between the load compartment and prime mover, and method of applying load are explained in Part I. For trafficking lanes 26 and 27, the load compartment was weighted to produce a load of 105,000 lb on a three-wheel-abreast tracking assembly. For trafficking, the load wheels were spaced 33 and 27 in. c-c for lanes 26 and 27, respectively. Three 56x16, 24-ply aircraft tires with inflation pressure of 100 psi were used and the three wheels were on a single axle. Tire-print data and pertinent tire characteristics are given in figure 17.

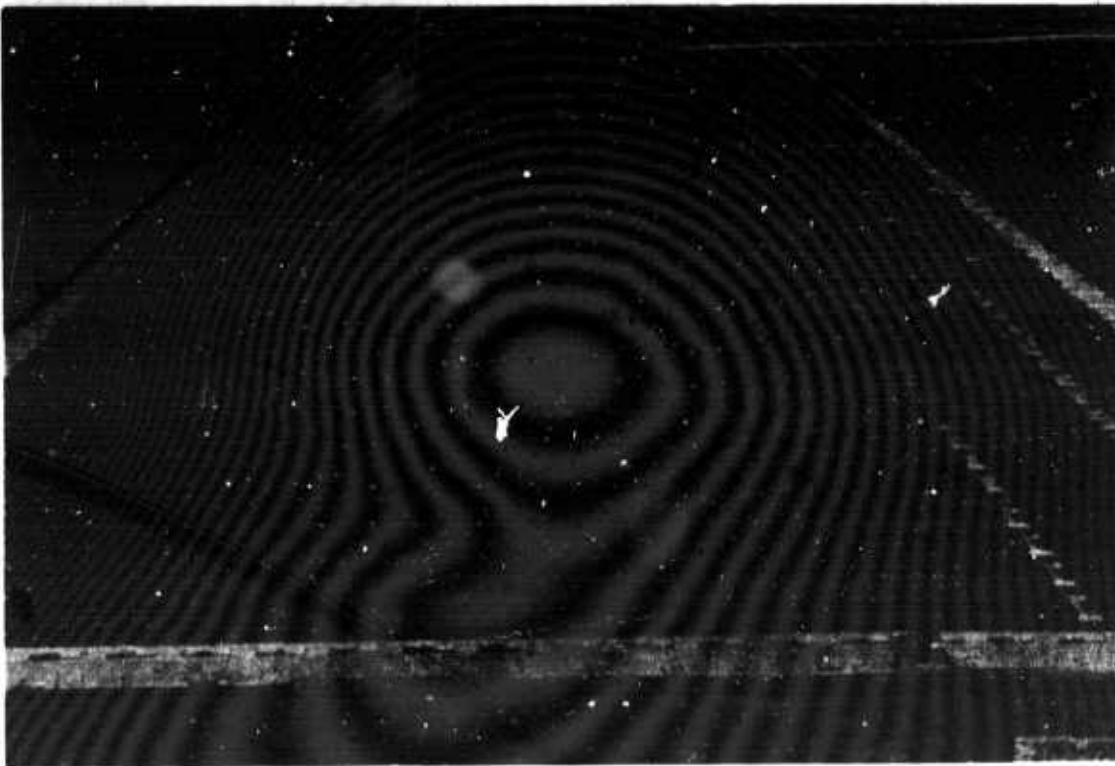
Figure 5. Lane 26, item 2, prior to traffic

Item 2. Item 2 prior to traffic is shown in figure 5. After 20 coverages, average mat deformation measured slightly less than 1 in. Traffic was continued to 150 coverages at which time item 2 was considered failed due to roughness. At failure, there was a considerable amount of subgrade extruded through the tubulated holes in the mat (figure 6). There were no mat breaks at failure. The rated CBR of the item was 3.7.

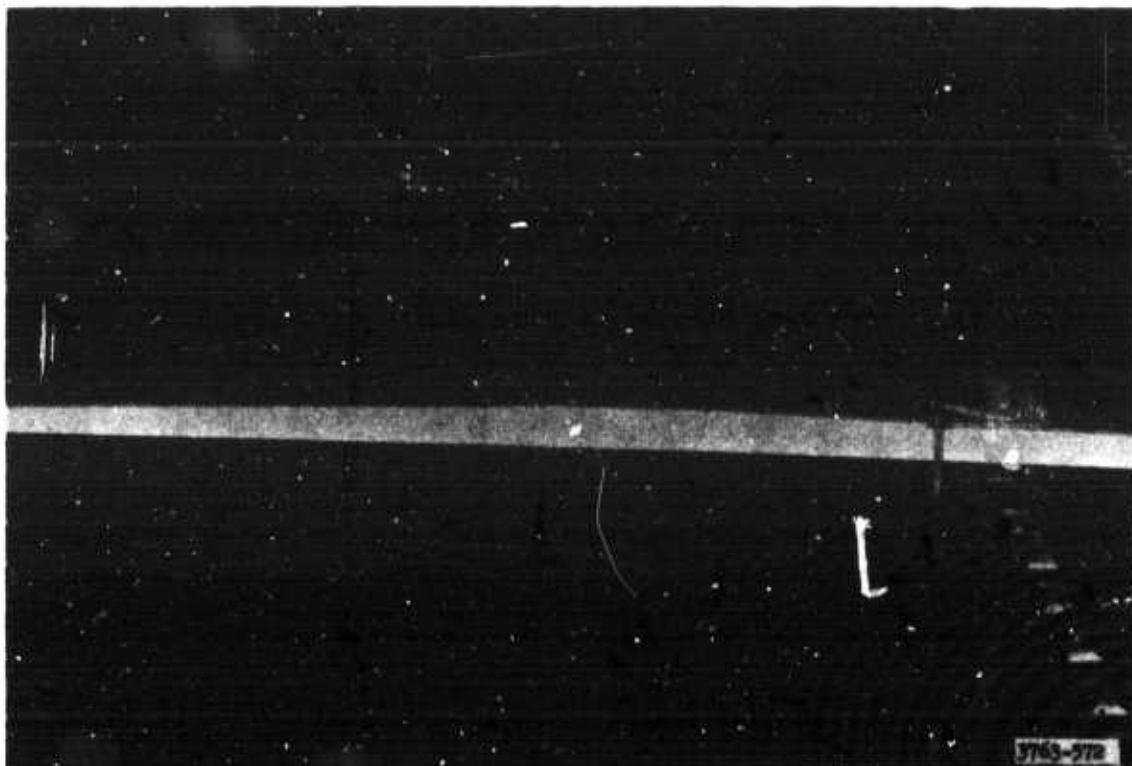
Figure 6. Lane 26, item 2. Transverse straightedge shows roughness at 150 coverages (failure)

- a. Roughness. Differential deformations increased steadily with traffic (table 1). Average transverse and diagonal differential deformations were 2.88 and 2.13, respectively, at failure. Dish-ing of individual panels averaged 0.25 in. at failure.

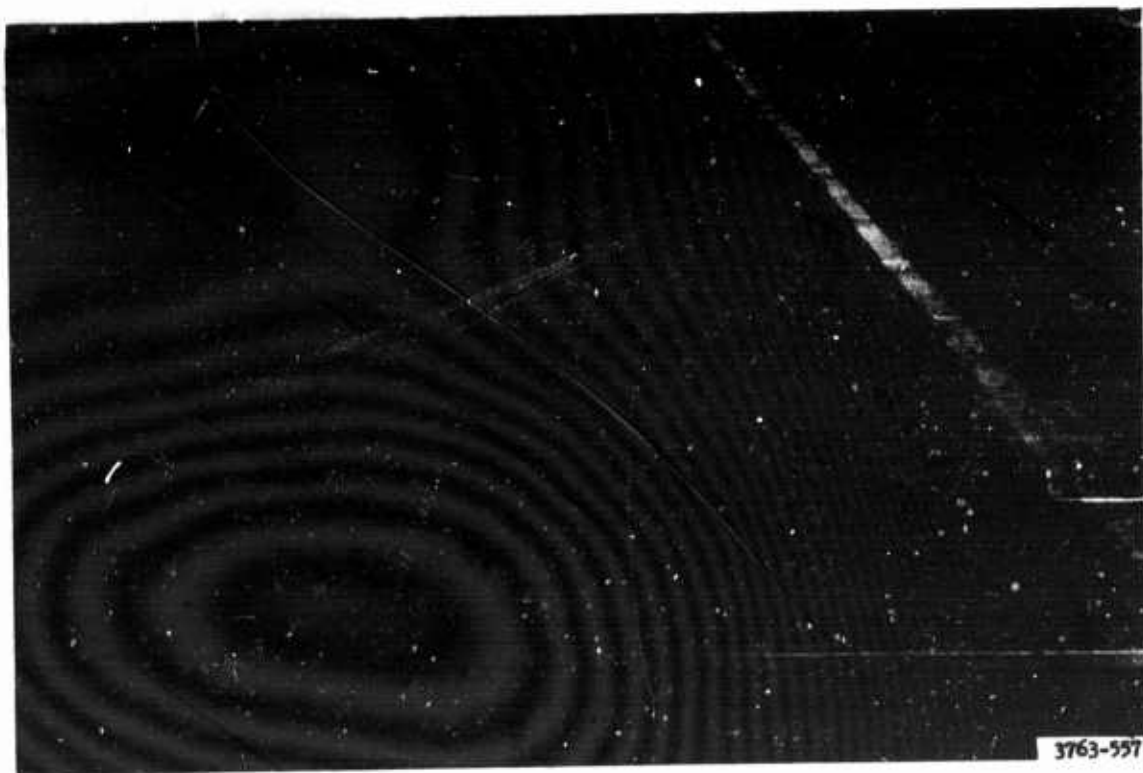
Figure 9. Lane 27, item 1, prior to traffic

Item 1. Item 1 prior to traffic is shown in figure 9. At 30 coverages, most of the center-line rivets in the panel in run 6 had sheared and the panel separated. At this time, mat runs 1-9 were eliminated from further consideration in testing. With continued traffic, additional panel center-line rivets failed and at 68 coverages the item was considered failed due to roughness and mat deterioration (figure 10). The rated CBR of the item was 2.4.

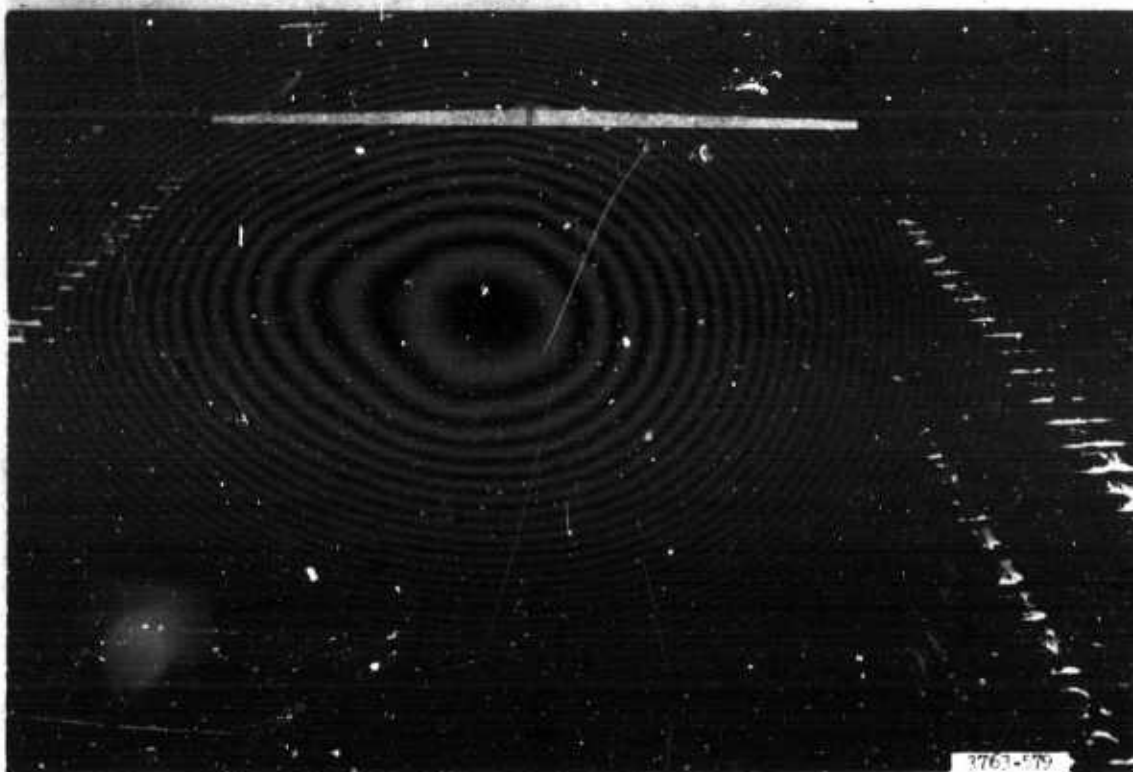
Figure 12. Lane 27, item 2. Transverse straightedge shows roughness at 68 coverages (failure)

Item 2. Item 2 prior to traffic is shown in figure 11. With continued traffic there was a considerable amount of subgrade extruded through the tubular holes in the mat. At 68 coverages the item was considered failed due to roughness (figure 12). The rated CBR of the item was 3.7.

- a. Roughness. Table 1 shows differential deformations and dishing at 20 and 68 coverages. At failure, average transverse, diagonal, and longitudinal differential deformations were 3.66, 3.63, and 1.10 in., respectively. Dishing of individual mat panels at failure averaged 0.19 in.
- b. Deformation. Average cross-section deformations, shown in figure 18, increased considerably with traffic. The profile deformations at 20 and 68 coverages shown in figure 19 indicate a general settlement of the test item with trafficking.
- c. Deflection. Average elastic mat deflections for three positions of the wheel assembly relative to panel end joints are shown in figure 21. Elastic mat deflections increased fairly consistently with traffic.
- d. Rolling resistance. All drawbar pull values increased with traffic (table 1).
- e. Mat breaks. No mat breaks were in evidence at failure.

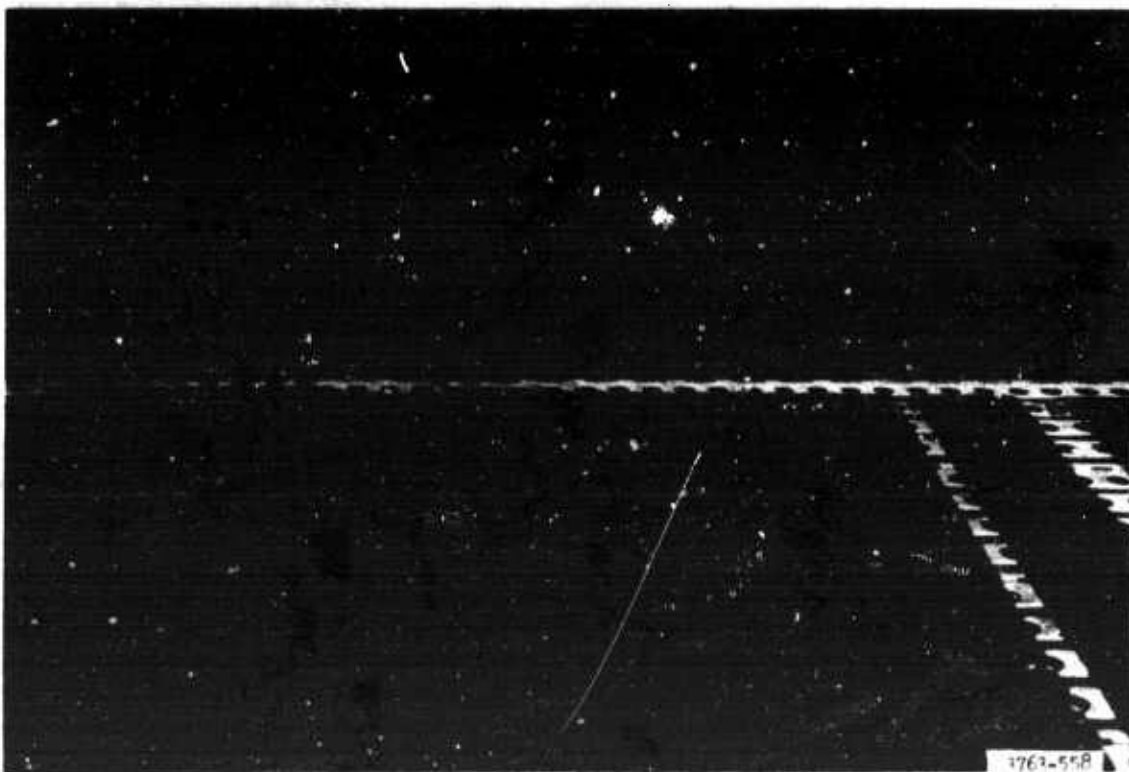
Figure 13. Lane 27, item 3, prior to traffic

Item 3. Item 3 prior to traffic is shown in figure 13. The item deformed rather easily under traffic and at 30 coverages was considered failed due to roughness (figure 14). The rated CBR of the item was 10.

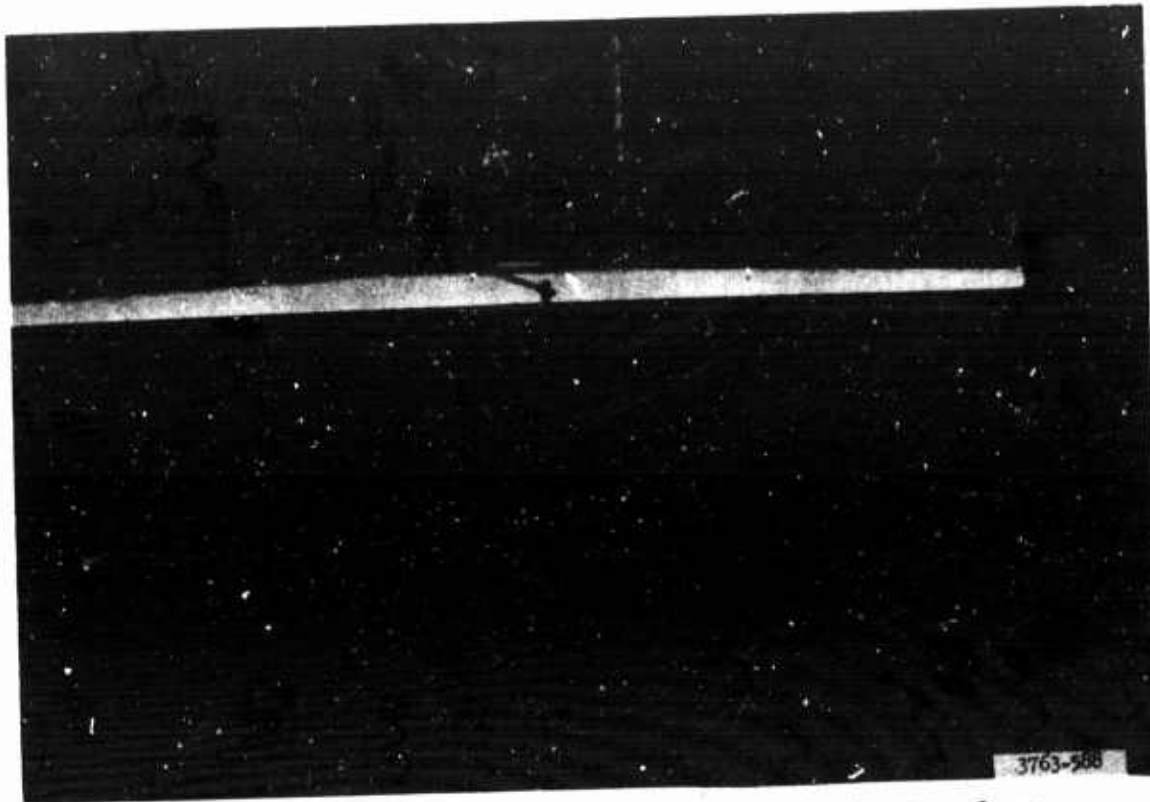
Figure 14. Lane 27, item 3. Transverse straightedge shows roughness at 30 coverages (failure)

- a. Roughness. Differential deformations and rut depths are shown in table 1 for 20 and 30 coverages. Average transverse and diagonal differential deformations (4.63 and 4.75 in., respectively) exceeded the average rut depth (3.75 in.) at failure.

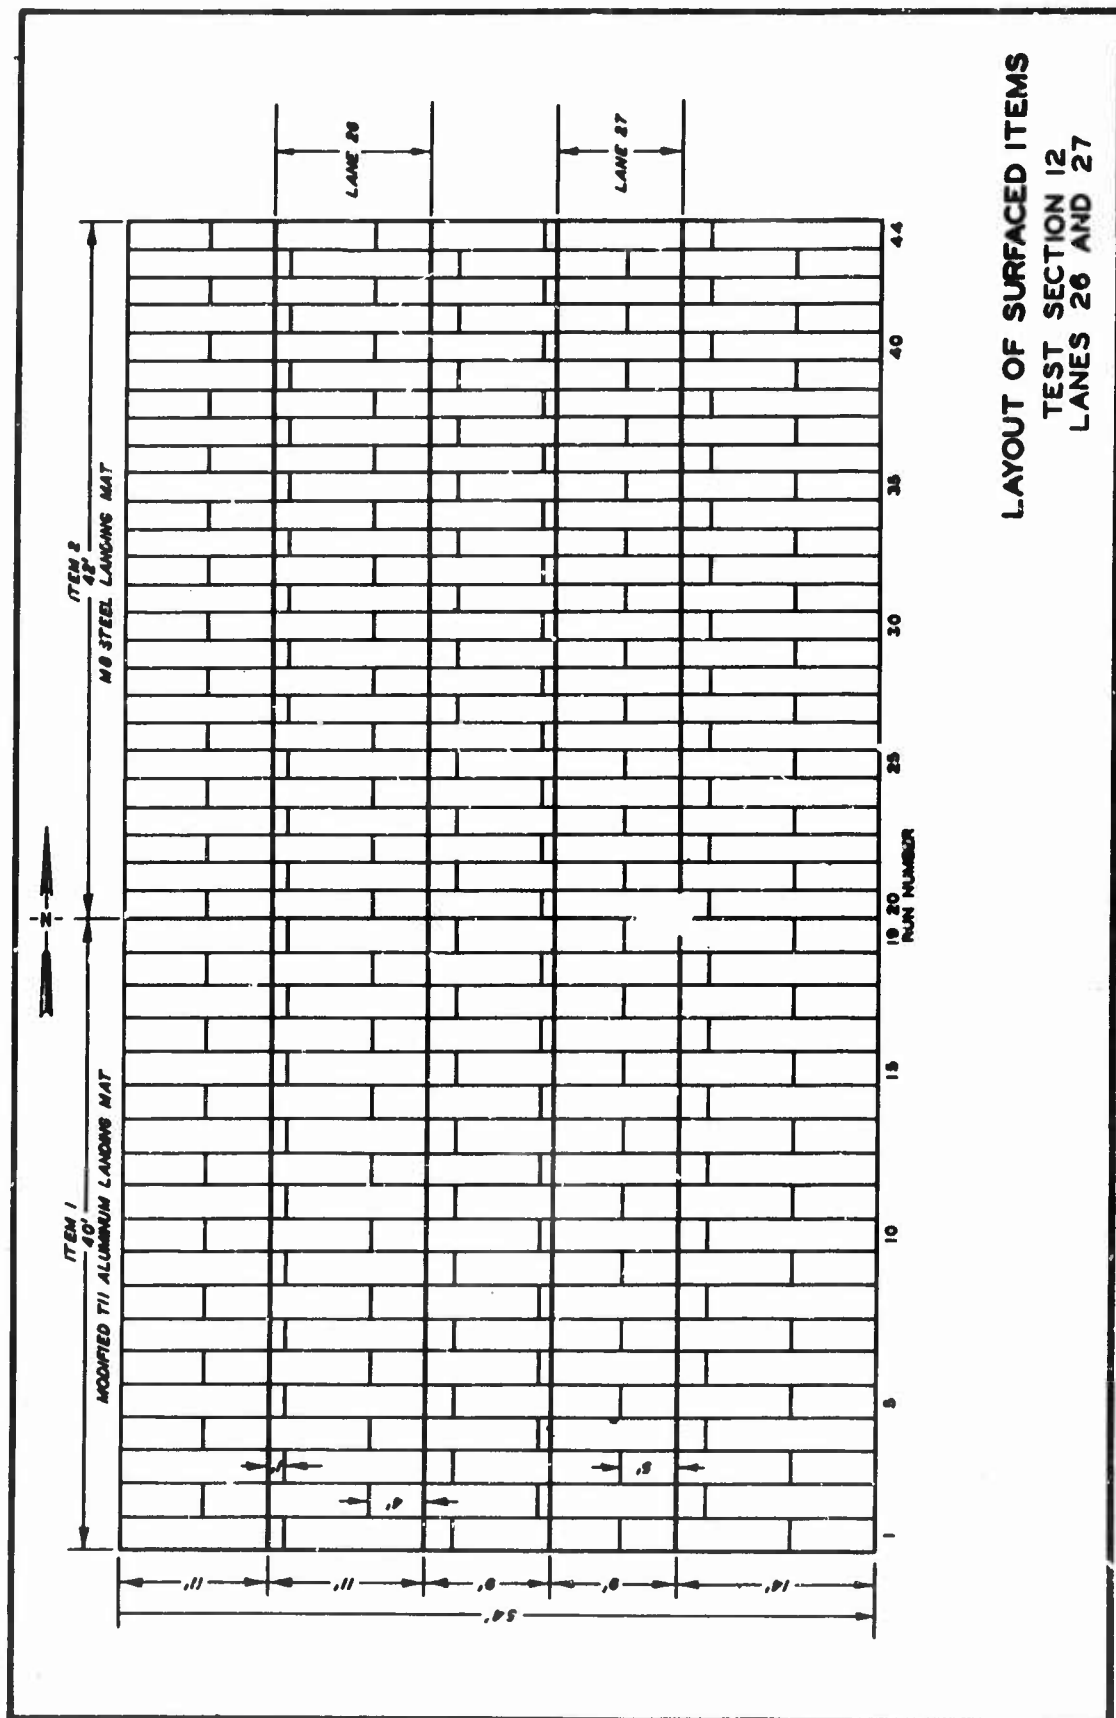
LAYOUT OF SURFACED ITEMS
TEST SECTION 12
LANES 26 AND 27

Tests on Section 12 are one phase of a comprehensive research program to develop ground-flotation criteria for heavy cargo-type aircraft. Section 12 consisted of two similar traffic lanes, lanes 26 and 27, each of which was divided into three items having different traffic surfaces and different subgrade CBR values (figure 15). Items 1 and 2 were surfaced with T11 aluminum and M8 steel landing mat, respectively (figure 16), and item 3 remained unsurfaced.

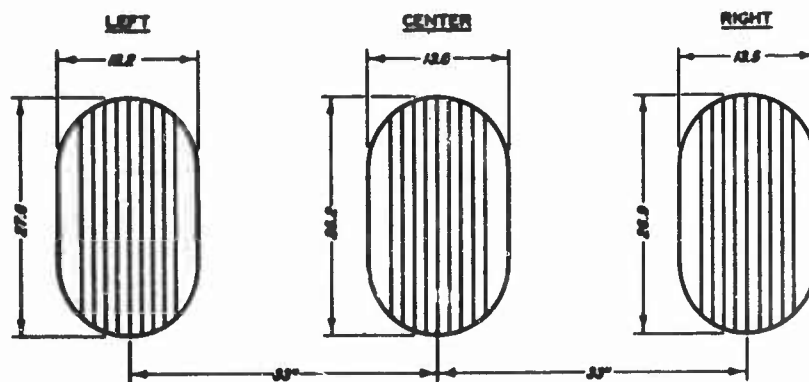
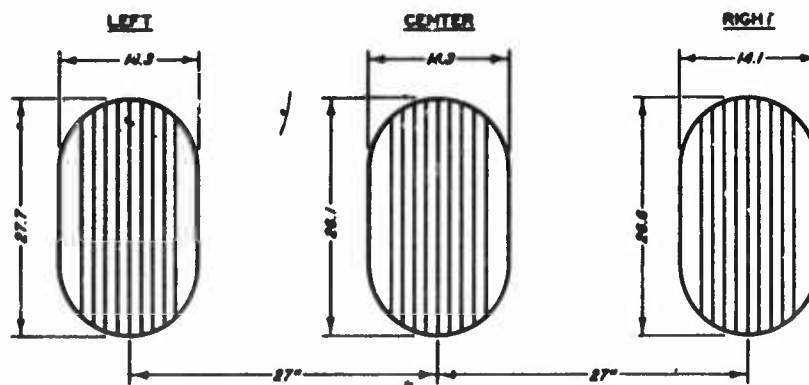
Figure 17

LEFT TIRE	CENTER TIRE	RIGHT TIRE
CONTACT AREA, SQ IN.	355	333	335
CONTACT PRESSURE, PSI	108	105	105
INFLATION PRESSURE, PSI	100	100	100
DEFLECTION, %	47	46	44
GROSS ASSEMBLY LOAD = 105,000 LB

LEFT TIRE	CENTER TIRE	RIGHT TIRE
CONTACT AREA, SQ IN.	348	334	333
CONTACT PRESSURE, PSI	101	105	105
INFLATION PRESSURE, PSI	100	100	100
DEFLECTION, %	51	45	44
GROSS ASSEMBLY LOAD = 105,000 LB

TIRE-PRINT DIMENSIONS AND TIRE CHARACTERISTICS

TEST SECTION 12
LANES 26 AND 27
56X16, 24-PLY TIRES

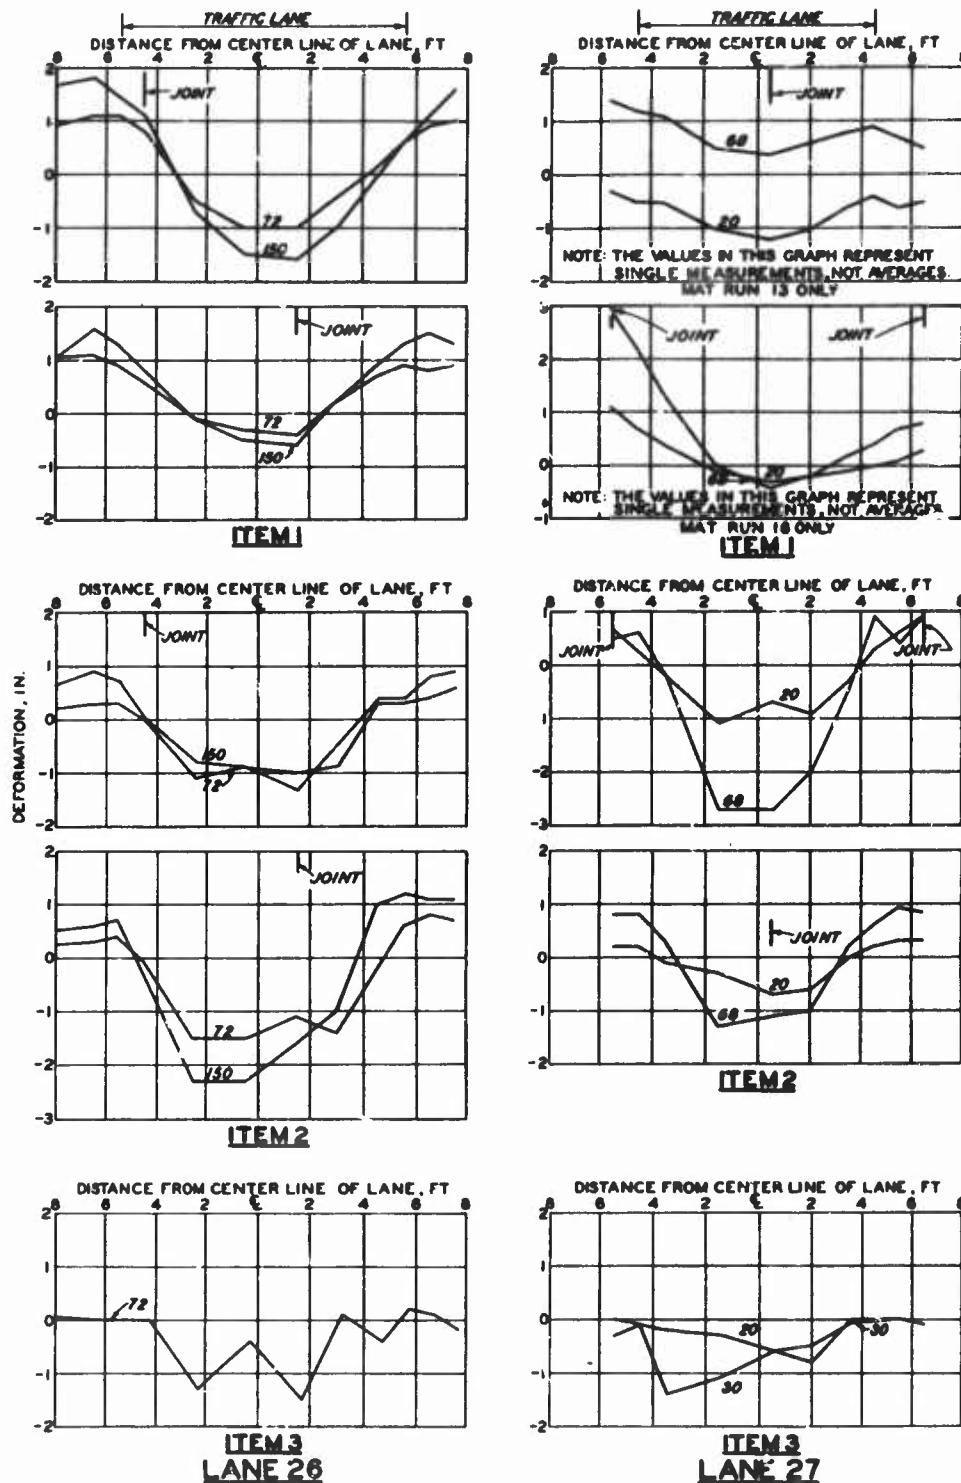
Figure 18

LEGEND
72 NUMBER OF COVERAGES

AVERAGE
CROSS-SECTIONAL
DEFORMATIONS
TEST SECTION 12
LANES 26 AND 27

- b. Deformation. Average cross-section deformations for the two typical mat runs are shown in figure 18 for 72 and 150 coverages. Figure 19 shows profile deformations for the same coverage levels.

- a. Roughness. Table 1 shows the steady development of differential deformations and dishing with continued traffic. Average transverse, diagonal, and longitudinal differential deformations at failure were 3.41, 3.88, and 3.38 in., respectively. Average dishing of individual panels was 1.22 in.
- b. Deformation. Cross-section deformations at 20 and 68 coverages are shown in figure 18. Due to elimination of runs 1-9 from

consideration, the cross-section plots do not represent averages but only single measurements at mat runs 13 and 16 as indicated. The elevated position of the mat surface at run 13 for 68 coverages was due to the extreme longitudinal deformations which resulted in transverse humps in the traffic lane. The very severe profile deformations that existed at failure are evident in figure 19.

- b. Deformation. Average cross-section and profile deformations at 20 and 30 coverages are shown in figures 18 and 19, respectively. Both figures indicate progressive deterioration under traffic with figure 19 showing settlement along the length of the item.
